HELIX

Autosport Ltd

PROCEDURE FOR CORRECT INSTALLATION OF CLUTCH COVER

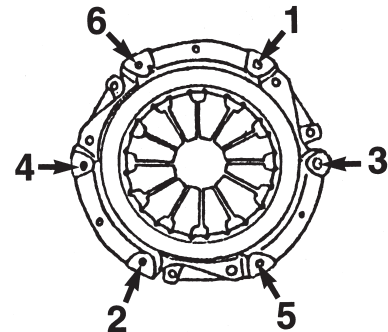
- ① INSTALL CLUTCH PROVISIONALLY BY HAND.
- ② TIGHTEN FLYWHEEL BOLTS DIAGONALLY AND EVENLY, TO O.E. SPECIFICATIONS.
